JOURNAL OF THE  
NUMISMATIC ASSOCIATION  
OF AUSTRALIA INC.

# The 1925 Shilling

Jon Saxton

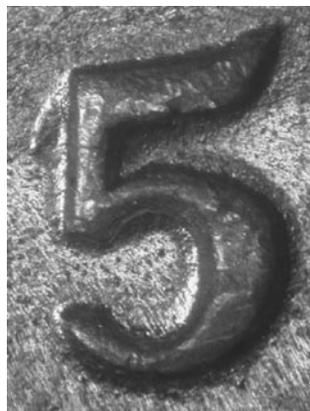
Figure 1. The curved tail resembling part of a 3 protruding from the upper part of the 5 led to the belief that the 1925 shilling is an overdate of the 1923 shilling.

Since the mid nineteen-sixties it has been a matter of faith among collectors of Australian predecimal coinage that the 1925 shilling is an overdated 1923 shilling. All 1925 shillings have what looks to be part of a 3 sticking out to the left of the upright segment of the date numeral 5 (Fig. 1). First reported in the November 1964 issue of the *Australian Coin Review*, this shilling was initially described as a variety, but that description was later corrected when it became obvious the protrusion was visible on all 1925 shillings. If anyone had found a 1925 shilling without a trace of the 3 then that would have been the variety; none has yet been found. The timing of the discovery

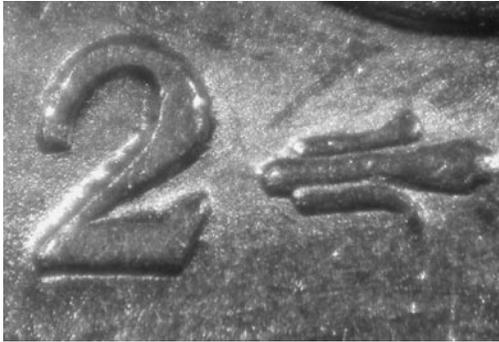
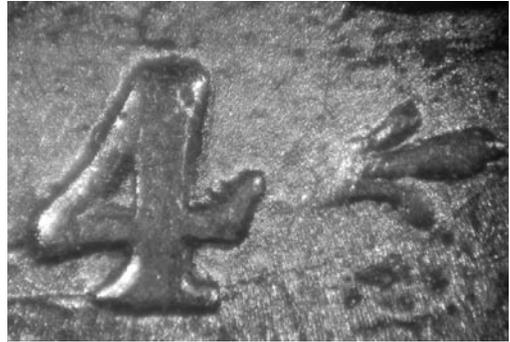
Figure 2. A 1922 shilling with the complete trefoil device, compared to a 1924 shilling showing the truncated trefoil which originated from the modified Melbourne Hub 192.

Now during the preparation of Melbourne Hub 192 something seems to have happened which yields an important clue as to the subsequent use of the shilling master tools throughout the twenties. It appears that the person responsible for grinding away the 3 was slightly over-zealous and took off a bit of the trefoil ornament to the right of the date. That this happened can be seen

clearly by comparing a 1924 shilling with an earlier dated one (Fig. 2). All shillings from 1924 to 1928 inclusive show this partially ground-off ornament although the 1928 coin is different from the others in ways discussed later in this article. Figure 3 illustrates the coins dated 1924-1927.

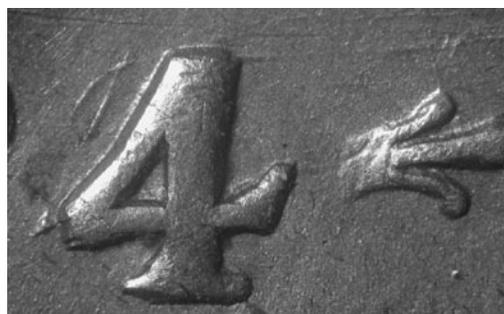
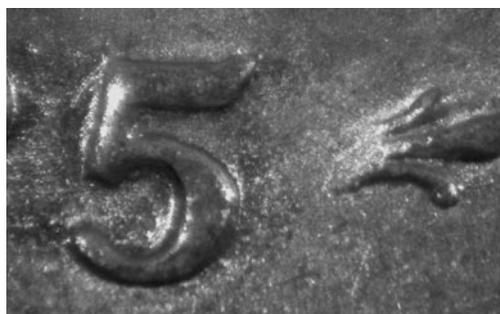
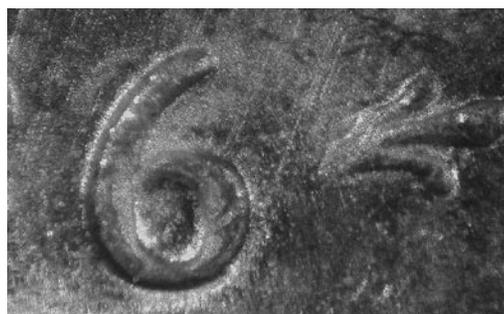
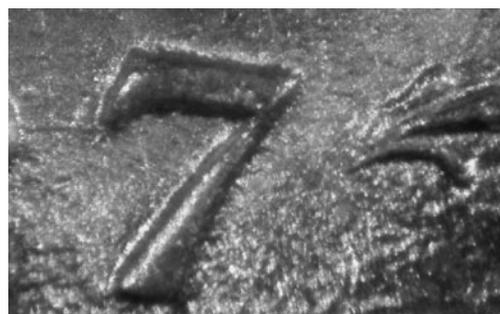
Figure 3. These four date details provide evidence that the truncated trefoil was propagated to all shillings from 1924 to 1927; the 1928 example is shown in Figure 8.

The 1924 shilling shows no trace of an underlying 3, suggesting that this digit was completely removed from Melbourne Hub 192. A curved ridge visible to the upper left of the 4 on some high-grade 1924 shillings (Fig. 3a) looks like it could be a trace of the original 3, but the straight

The 1926 master die was prepared from Melbourne Hub 192 on 15 October 1925 and the 1927 master die was prepared on 11 October 1926. The die records are not as detailed for 1927 and do not mention Melbourne Hub 192 but an examination of 1927 shillings indicates that that tool was indeed the one used (see Fig. 3d).

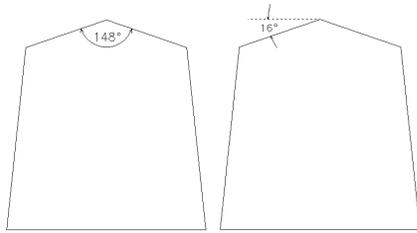
Figure 5. Profiles of die forgings used at the Royal Mint in London. The second example shows the way the cone angle was measured at the Melbourne mint.

taper. In the language of the Melbourne mint that would have been a  $16^\circ$  blank because Melbourne measured the angle from the horizontal (see Fig. 5). The reason for using tapered blanks is that it reduces the amount of plastic flow of metal needed to form the design and so enables the design to be rendered sharply with less pressure than would otherwise be necessary.

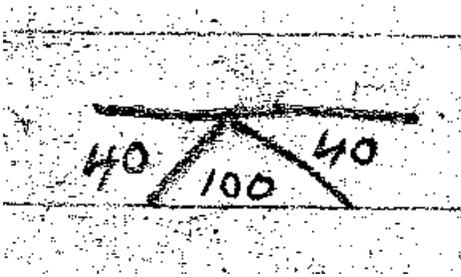
Figure 6. Sketch from the Melbourne Mint Workshop Die Book of a  $40^\circ$  blank. The text accompanying this sketch mentions forgings turned to  $10^\circ$ ,  $20^\circ$ ,  $40^\circ$  and  $60^\circ$ , and states that the 1924 and 1925 shilling master tools were made from  $60^\circ$  blanks.

varying from 10° to 60° (Fig. 6). In 1925 the shilling tools were pressed from a blank turned to a 60° angle (Fig. 7). With such a pointy cone, the first blow would not have rendered the shilling image to its full diameter. If this first blow had been made with the London hub, then just a bit of the top of the 3 might well have been impressed onto the die. Neither the second blow with the correct hub nor the subsequent punching of the final 5 would necessarily have obliterated all traces of the 3.

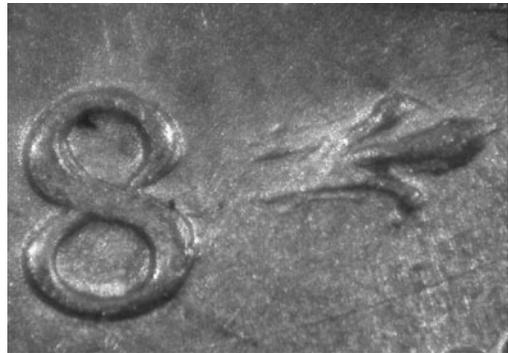
Figure 8. A 1928 shilling showing traces of the untruncated trefoil, which may have come from the unmodified London Hub 1923.

There is no trace of an underlying 3 to be seen on the 1928 shilling since the overlay of an 8 would closely match the 3 and obliterate it. A clue comes from the truncated (partly removed) trefoil device to the right of the date (Fig. 8). Its overall form is identical to those on the 1924-27 shillings and clearly it was carried forward from Melbourne Hub 192. However, the 1928 ornament differs from those on the other shillings of the series in that it also shows traces of the untruncated device (the original trefoil before the Melbourne Hub 192 grinding error). Those traces had to have come from some other tool and the only candidate would be London Hub 1923. Some support for this conjecture comes from the doubling of some details noticeable on the reverse of the few 1928 shillings in my collection. This doubling is clearly visible on coins in VF or better condition and occurs on the date (Fig. 9),

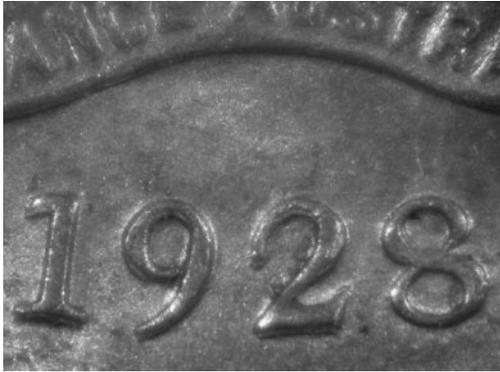
Figure 9. Date area of a 1928 shilling showing outward radial doubling of the date and the lower edge of the scroll.

the lower edge of the scroll, and the letters ING of SHILLING. The doubling had to have been present on the master die and one possible cause of such doubling is the use of two distinct hubs.

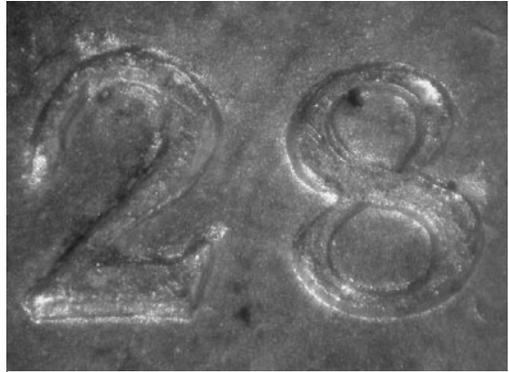
Figure 10. The secondary image of the 2 is essentially downwards while on the 8 it is to the right and slightly upwards. The two doublings had to have come from different mechanisms.

On the 1928 shilling there is doubling visible on all digits of the date. At first that would seem to argue against the two-hub hypothesis in that we would not expect the 8 to be doubled because Melbourne Hub 192 could not have stamped an 8 onto the master die. However, close study of the 8 shows that the displacement of the secondary impression is in a direction about 120° to that of the scroll and the other digits (Fig. 10) and so cannot have been produced in the same way. Furthermore, the doubling of the 8 is clearly not a residue of an underlying 3 and probably occurred during hand-punching.
